Case	(401) Be aware of the osteosynthesis material: is it really normal? ("broomstick break")
Authors	G. Pérez Hernández, A. Blanco Barrio, M. Lozano Ros, I. García Tuells, I. Herves Escobedo, I. Cases Susarte.
Centre	Hospital Universitario Morales Meseguer.

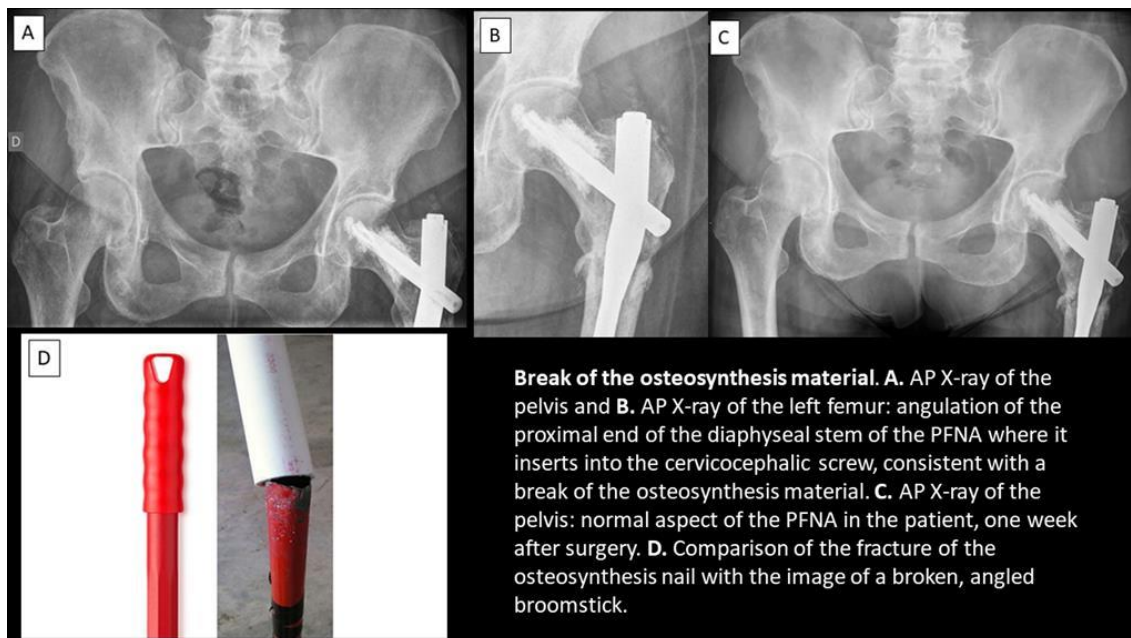
At the ER, AP radiographs of the pelvis and AP and axial radiographs of the left femur were requested. The gamma nail and the pathologic fracture through a lytic lesion in the left femur could be depicted.

Moreover, there was an abnormal angulation of the proximal end of the diaphyseal stem in the area where it inserts into the cervicocephalic screw, consistent with a break of the osteosynthesis material. The patient was admitted for surgical treatment.

The break of the implant is a relatively rare complication. In most cases it is due to the fatigue of the material (absence of fracture consolidation or technical errors in its placement). If a complication of the osteosynthesis material is suspected, radiographs of the hip and femur should be performed to confirm the suspicion.

The nail break will appear as an angulation of the nail compared to its normal position. It is important to compare with previous images, as subtle angulations may remain unnoticed. When the break of the osteosynthesis material occurs, the treatment consists of extracting the osteosynthesis material and performing a new osteosynthesis with a long PFNA.
