Case	(711) Spine fracture in ankylosing spondylitis
Authors	S. Larburu Zavala, L. Prada San Martín, B. Souto Cantelli, A. Dolado Llorene, L. Rubio Romero.
Centre	Osakidetza Hu Cruces.

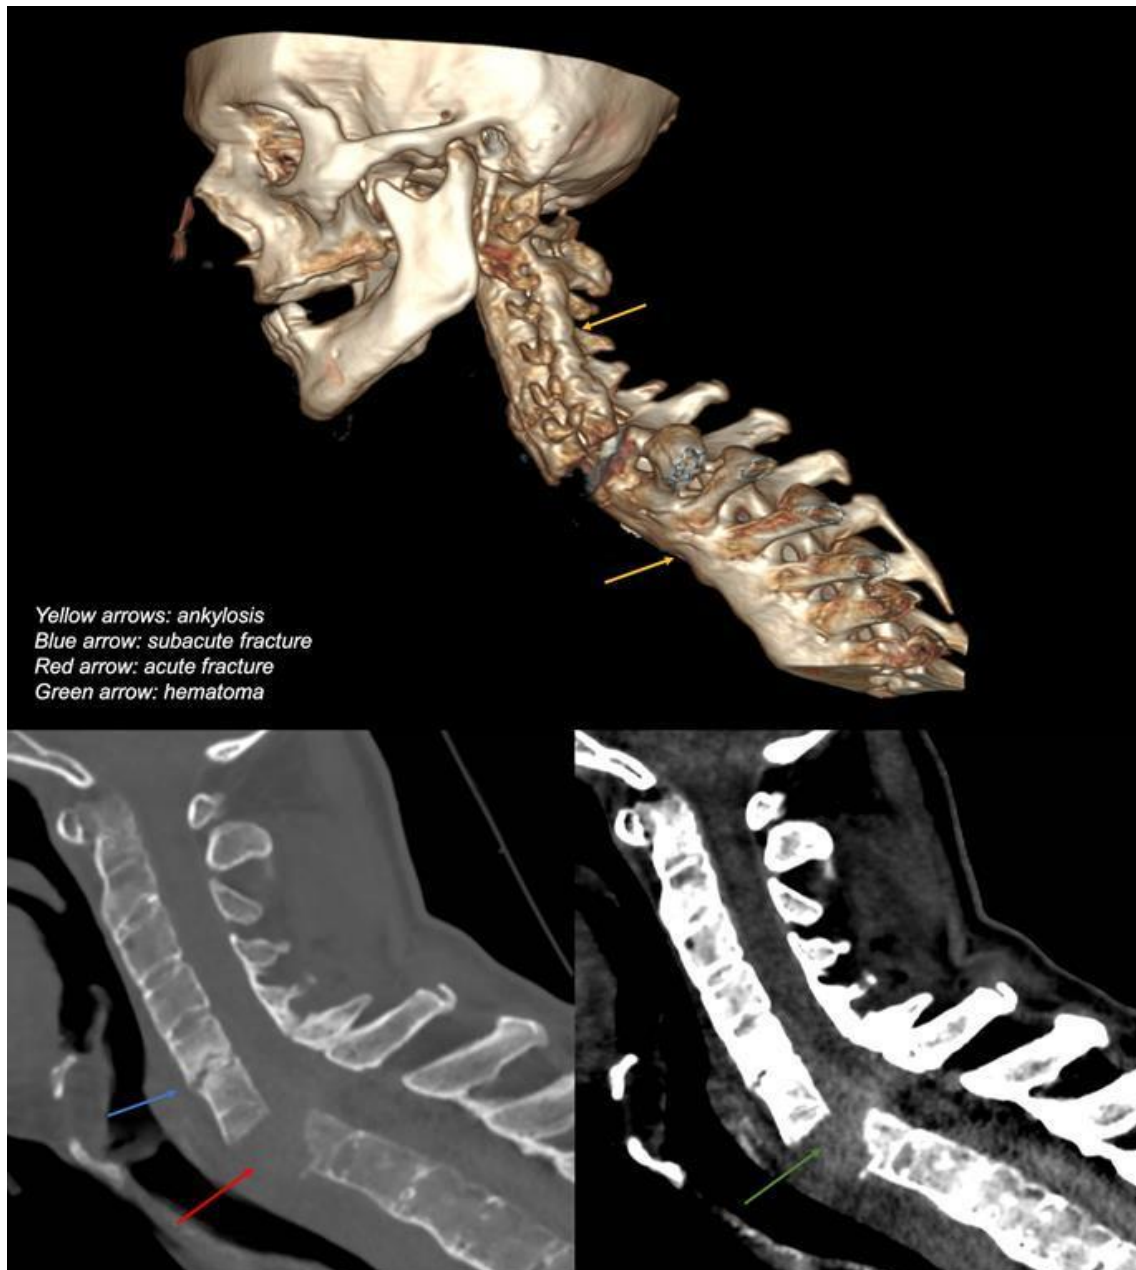
The sagittal spine computed tomography (CT) images reveal a hyperextension fracture pattern of the C7 vertebral body (red arrow) extending diagonally upwards and through posterior elements with anterior displacement and separation of the proximal spine as well as extensive hyperdense material in the spinal canal indicating hematoma (green arrow). Additionally, a C5-C6 disk fracture (blue arrow) is demonstrated, being the fracture edges sclerotic, as it is a subacute fracture.

As manifestations of the ankylosing spondylitis bridging syndesmophytes, (which cause the fusion of the vertebral bodies), and diffuse ankylosis of the facet joints can be seen in the volume rendering image (yellow arrows).
